HORSESHOE LAKE BIOASSESSMENT
MARCH, APRIL, AND MAY 2015

Below, please find the latest bioassessment for your lake. Key highlights of this assessment include:

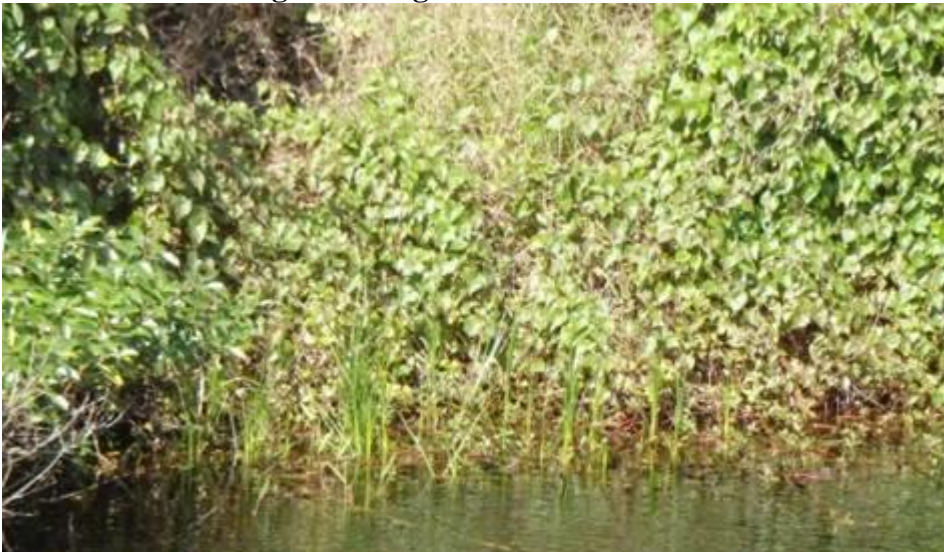
Photo: Burhead sedge and alligator weed.

Other invasive species included: alligator weed, water sprite, wild taro, water hyacinth, primrose willow, torpedo grass, burhead sedge, and salvinia. Alligator weed is starting to grow back in small pockets throughout the lake. Four small patches of water hyacinth were spotted. We encourage hand removal of water hyacinth from the lake. This practice will control the population of this invasive plant which has a reputation of spreading rapidly.

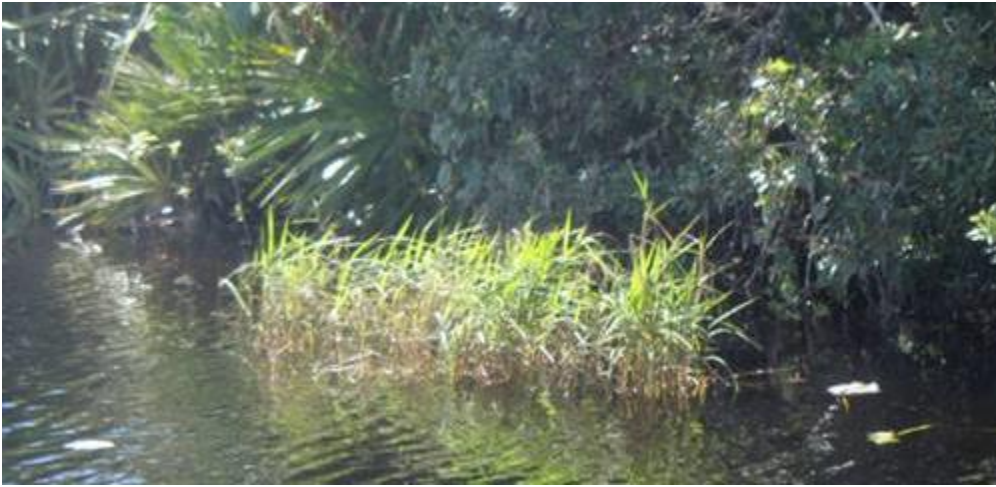
Photo: Patch of maidencane.

Native emergent vegetation found during the inspection included: bur marigold, canna, saw grass, pennywort, duckweed, southern watergrass, hemp vine, yellow cow lily, fragrant water lily, climbing aster, maidencane, arrow arum, pickerelweed, duck potato, lizards tail, bulrush, and fire flag. Hemp vine is spreading throughout the trees and bushes of the shoreline.

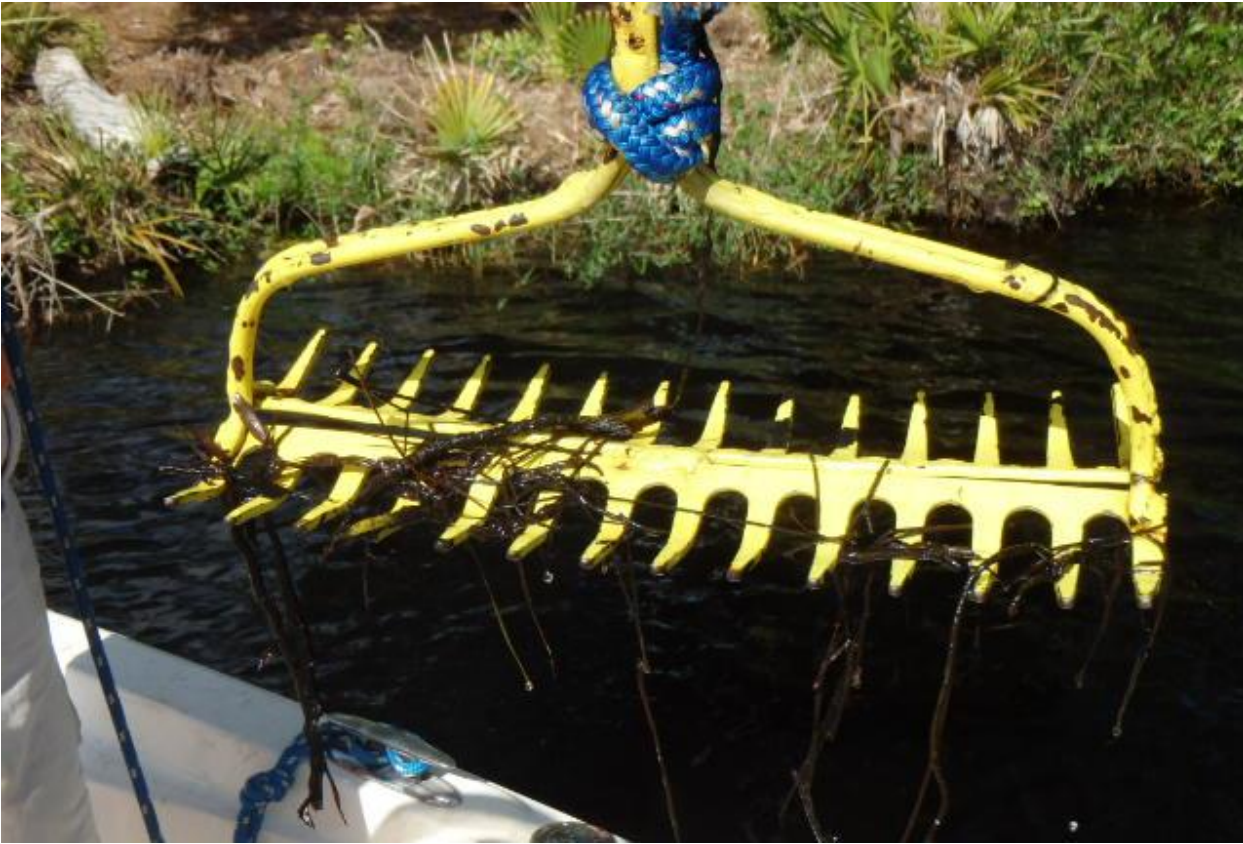
Photos: Lake bottom debris.

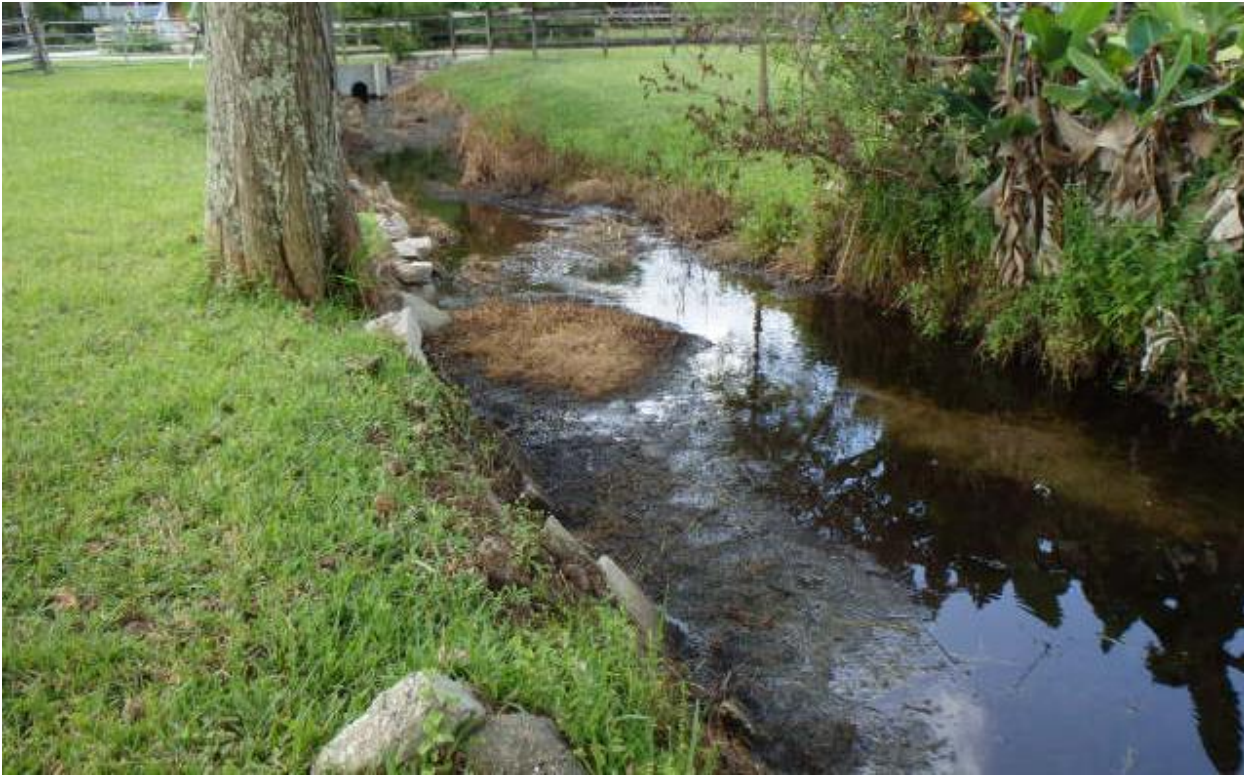
Hydrilla was observed in the north canal only at the headwall of the stormwater structure and was found impacted from recent herbicide treatment.

Photo: Treated Canal.

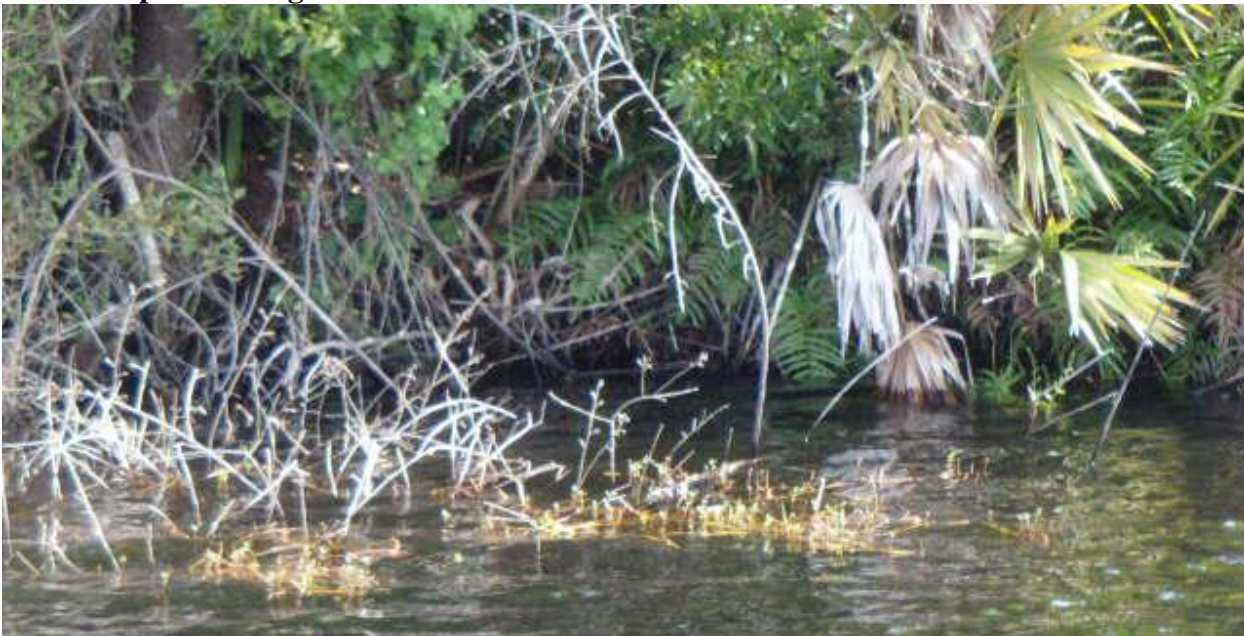
Other invasive species included: alligator weed, wild taro, water hyacinth, primrose willow, torpedo grass, burhead sedge, and salvinia. Alligator weed and bur-head sedge were heavily impacted from the recent treatment.

Photo: Impacted Alligator weed.

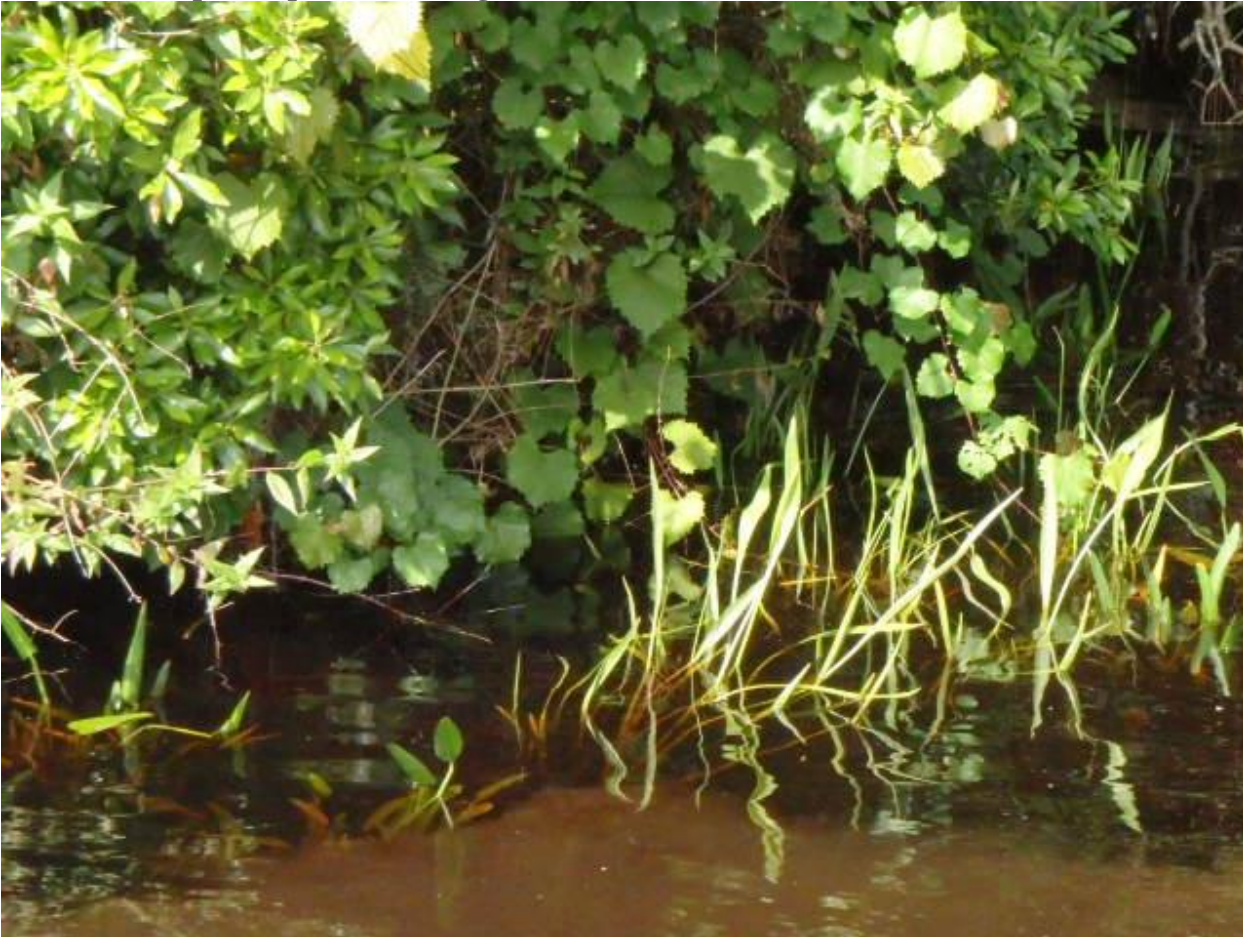
Much of the native vegetation planted during the March 28th restoration event was found in good condition. Only a few pop ups were found. Although many of the plants were underwater they should survive. It was noted that there is an increase in both lily pads and maidencane in the lake overall. This should enhance fisheries habitat.

Photos: Duck potato planted during restoration event.

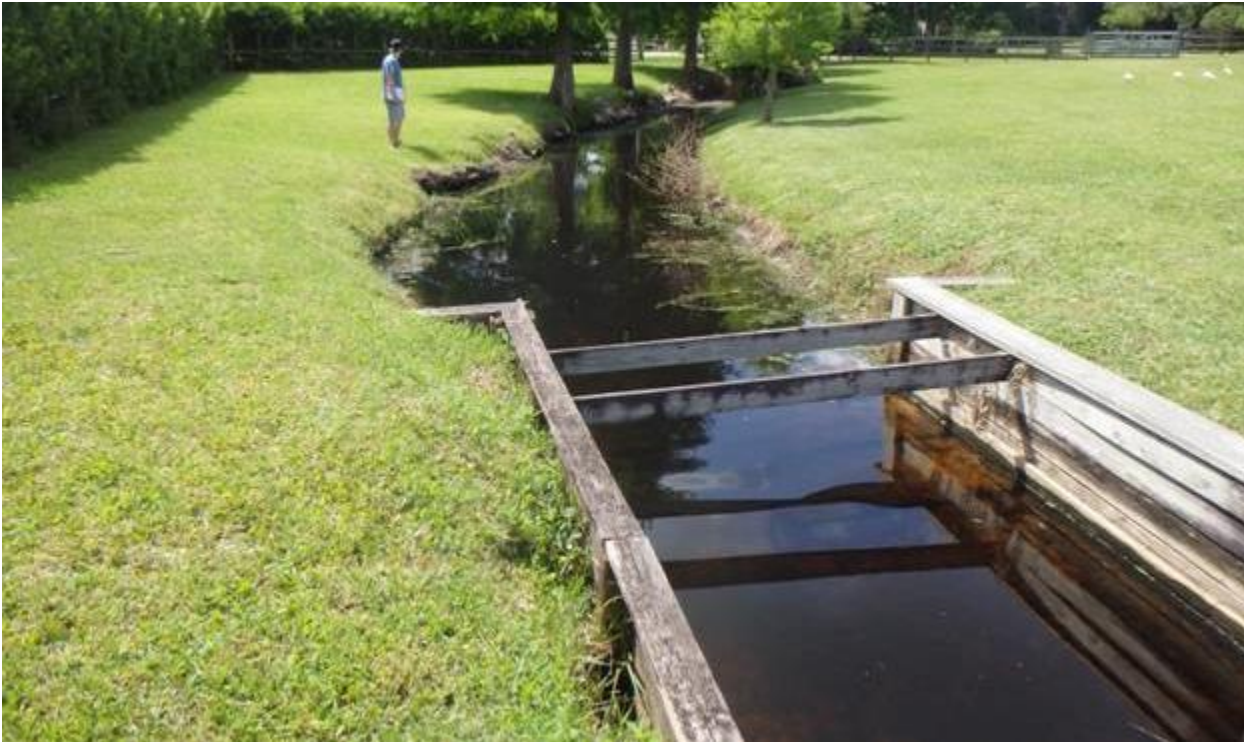
No hydrilla was found during this inspection. Only small amounts of alligator weed and torpedo grass were found in the canal.

Photo: Treated canal.

Other invasive species included: alligator weed, wild taro, water hyacinth, primrose willow, torpedo grass, bur-head sedge, and salvinia. Alligator weed is starting to grow back in small pockets throughout the lake. This and torpedo grass will be targeted during the next herbicide treatment. No water hyacinths were observed during this inspection.

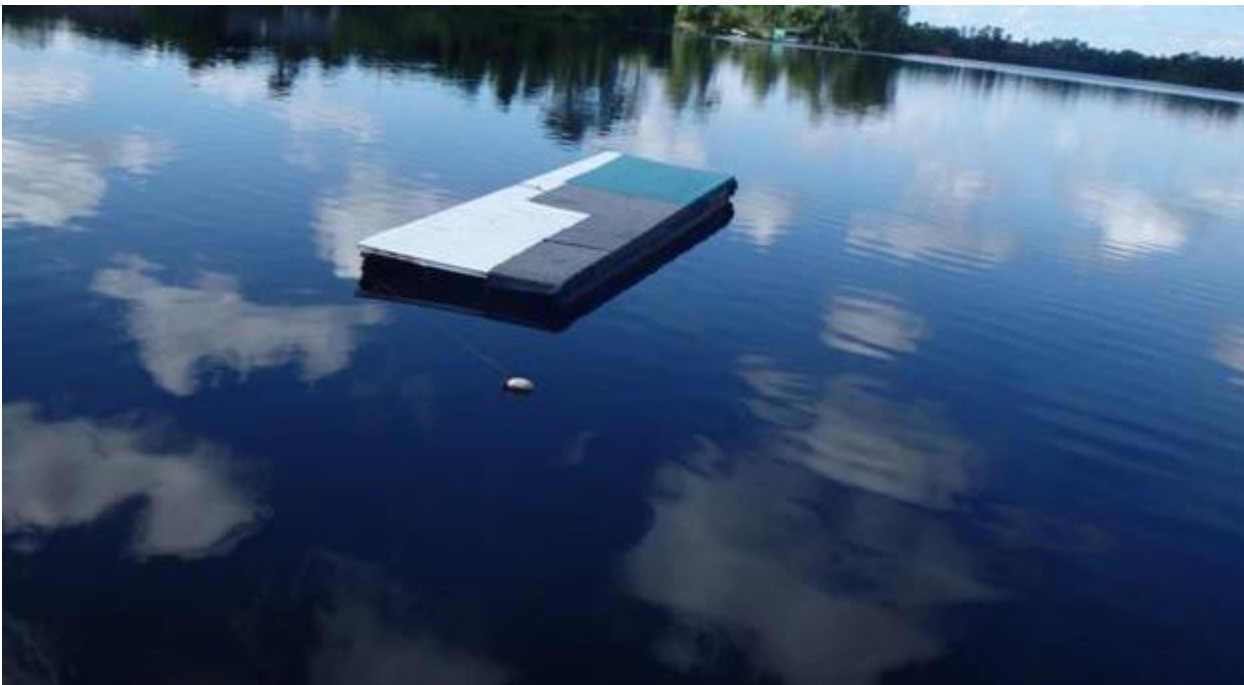
Photo: Free and clear ski dock.

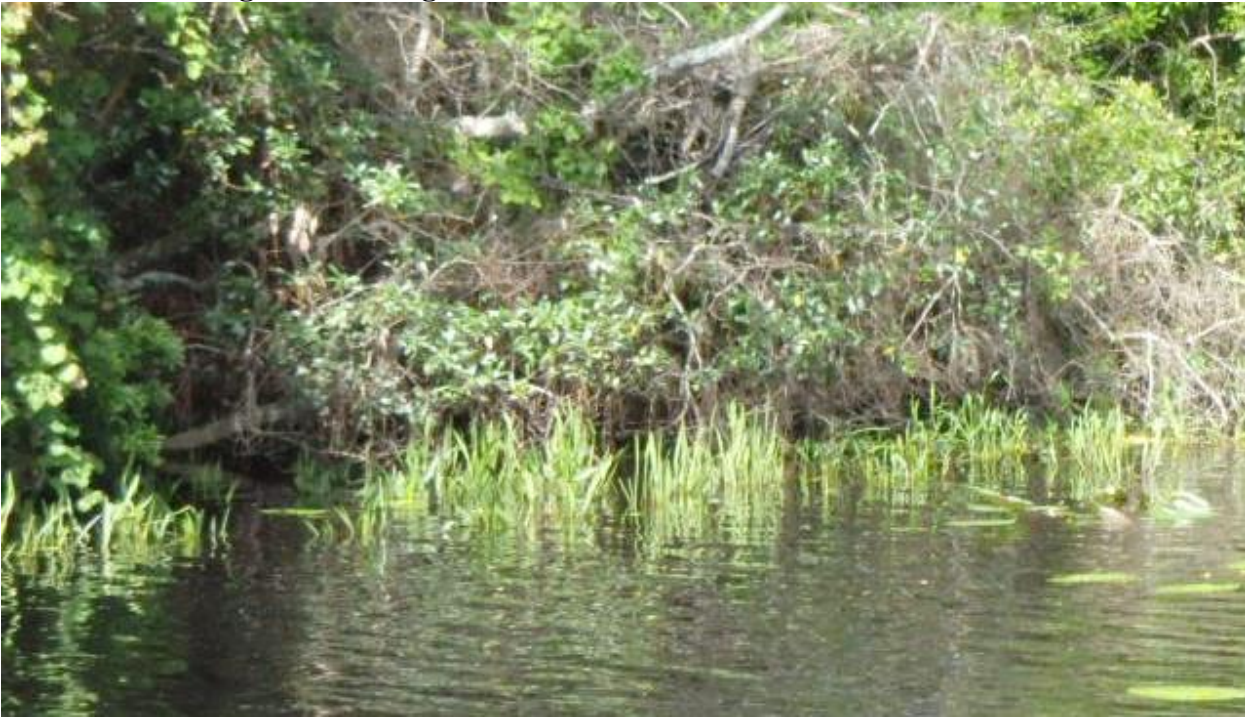
Much of the native vegetation planted during the March 28th restoration event were found in great condition.

Photos: Native vegetation filling in at outfall canal.

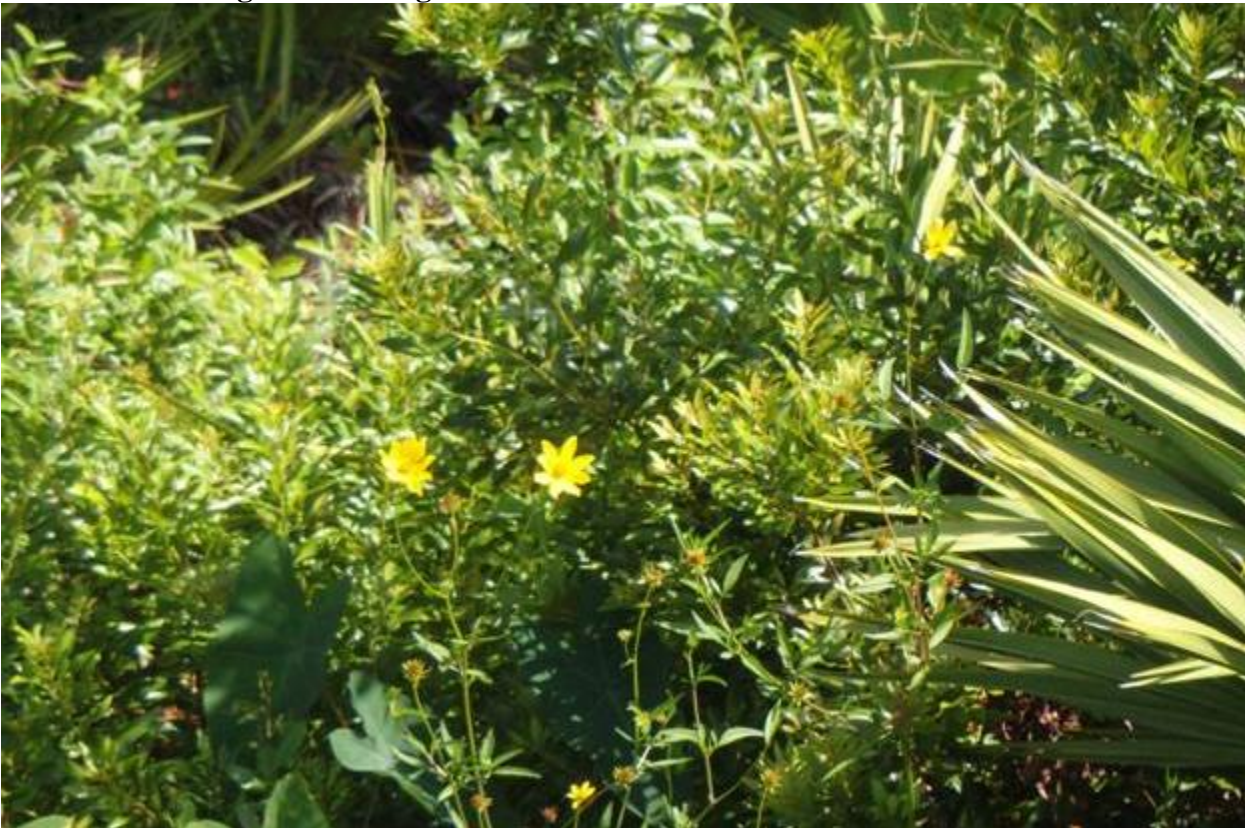
Native vegetation including duck potato, pickerelweed, fire flag, lizards tail and southern water grass was found expanding around the lake. Native SAV found included eelgrass, baby's tears and roadgrass. Baby's tear was expanding in many areas. It was noted that both native species button bush and bur-marigold were blooming.

Photo: Bur-marigold blooming.
